# New York State Department of Transportation

## Yellow Flag NB2228W020

Yellow Flag No. NB2228W020

Location: Span 306 at Pier 306, Floorbeam FB4 between Stringers S5 and S6 (Photo 1).

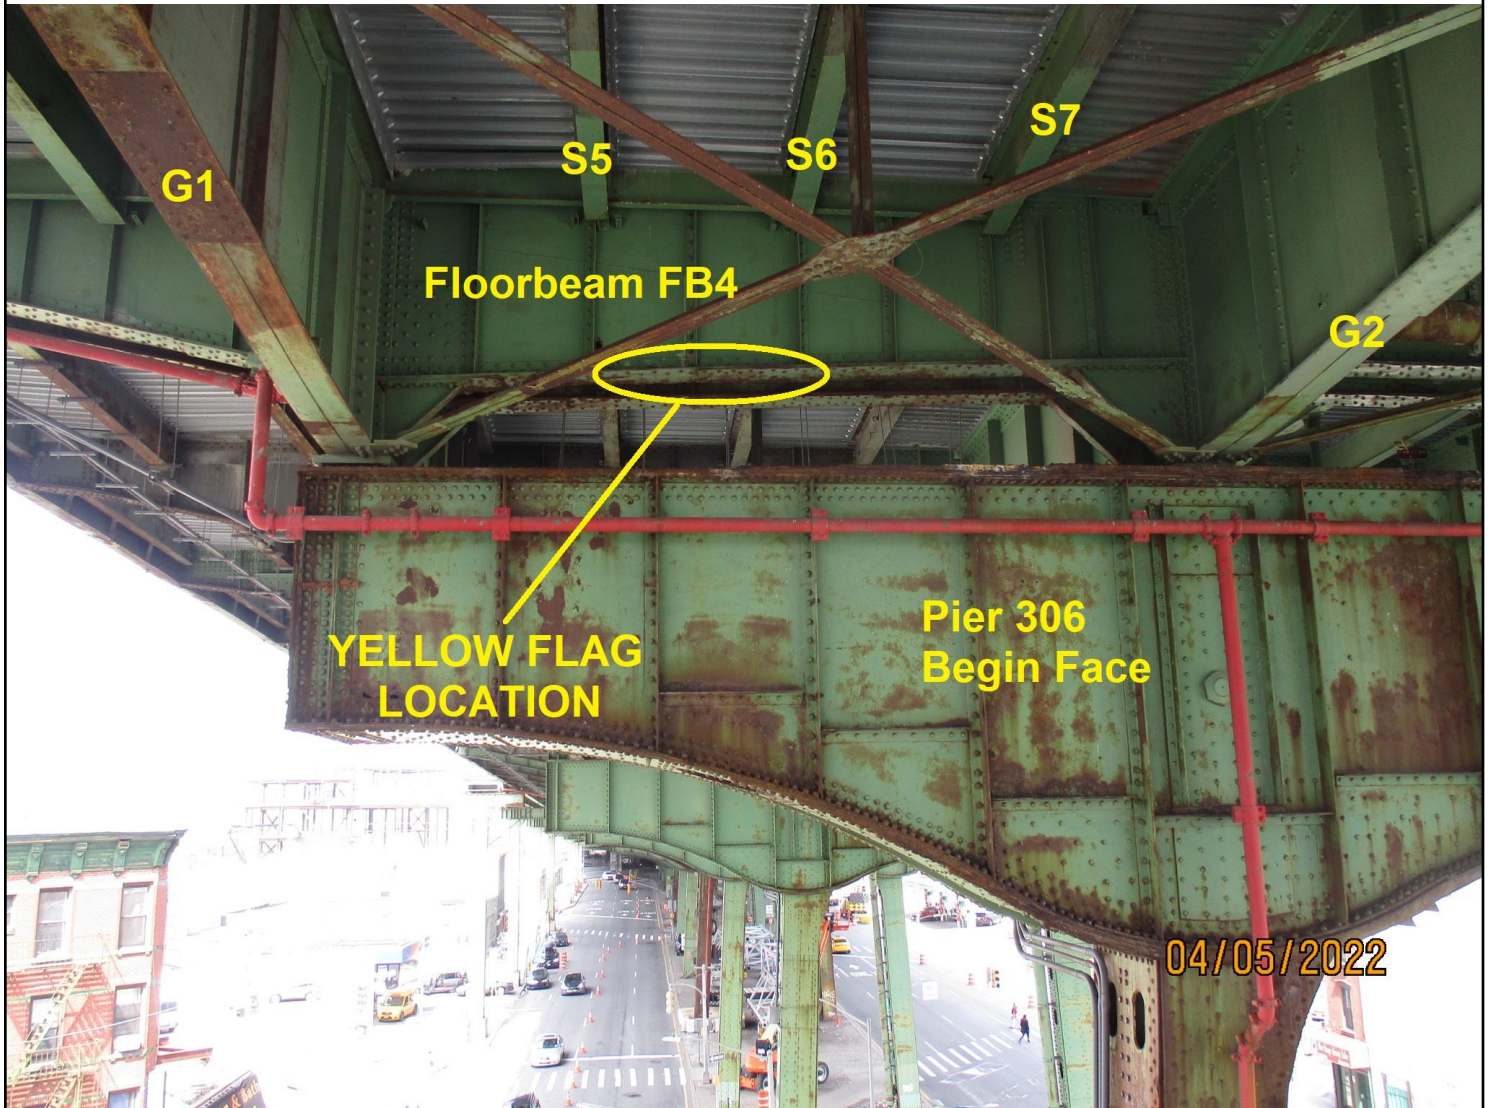
Photo Number: 1

**Attachment Description:** Span 306 at Pier 306 between Girder G1 and G2. General view of the flagged location. Looking End.

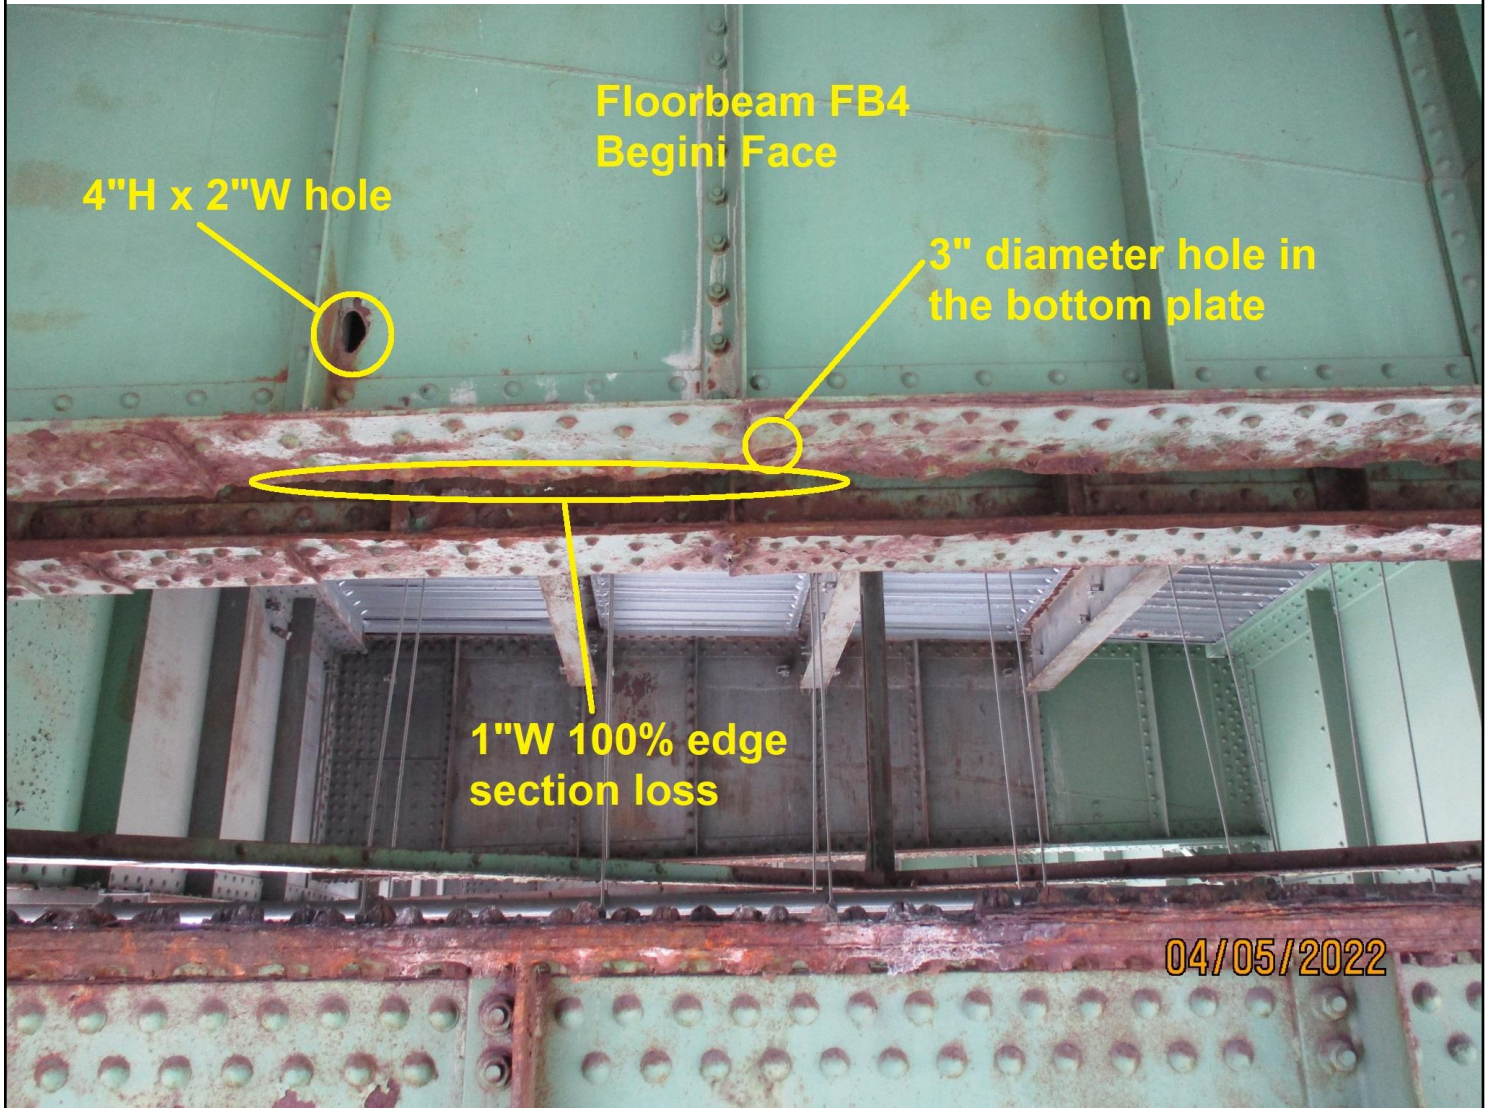
Photo Number: 2

Description: Floorbeam FB4 bottom flange exhibits 100% section loss over a 3"L x 2"W area and 1" wide area of 100% edge section loss for 6' on the end portion of the floorbeam inside the joint at mid-span (Photo 2 and 4). At this location, the FB4 bottom flange exhibits overall section loss ranging from 18% to 21% due to the difference configuration of the bottom flange (Photo 3).

**Attachment Description:** Span 306 at Pier 306, Floorbeam FB4 begin face between Girders G1 and G2. Bottom flange deterioration with edge section loss and holes. Looking End.

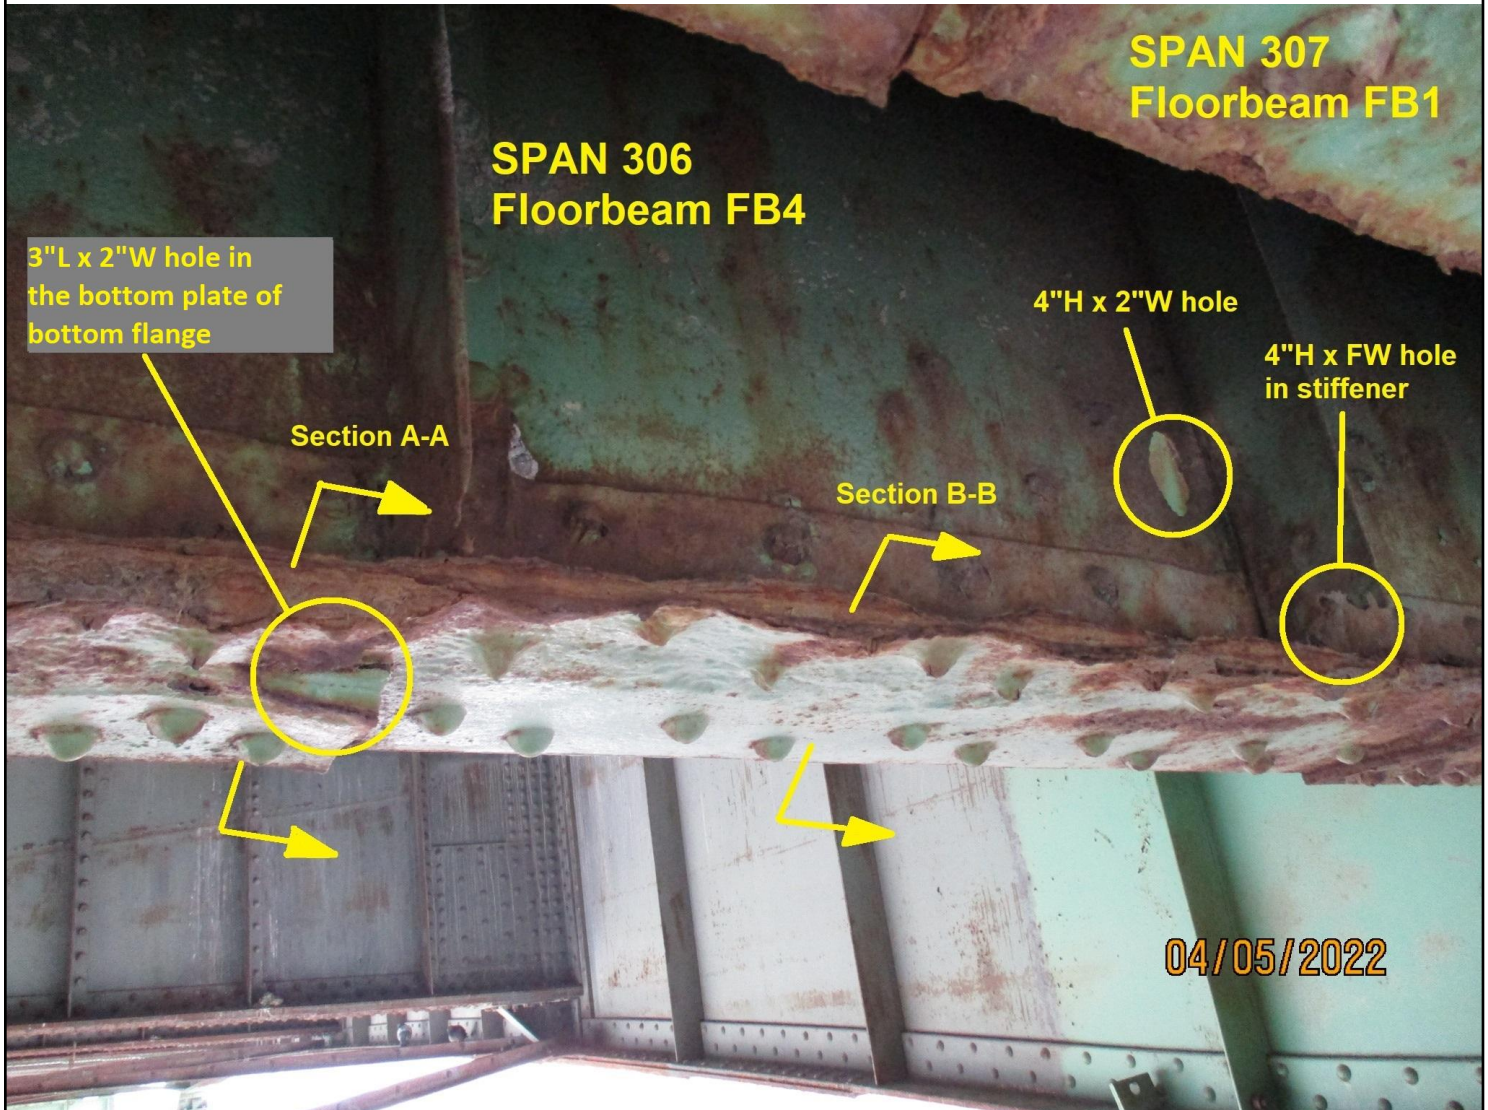
Photo Number: 3

1.The FB4 exhibits pack rust up to 1" high between the bottom flange and cover plate for the full length between Girders G1 and G2. End side of the floorbeam exhibits up to 4"H x full width corrosion hole in the bottom of the stiffeners. (Photo 3).

**Attachment Description:** Span 306 at Pier 306, Floorbeam FB4 between Girders G1 and G2. Bottom flange deterioration and corrosion holes in vertical stiffeners. Looking Begin Left.

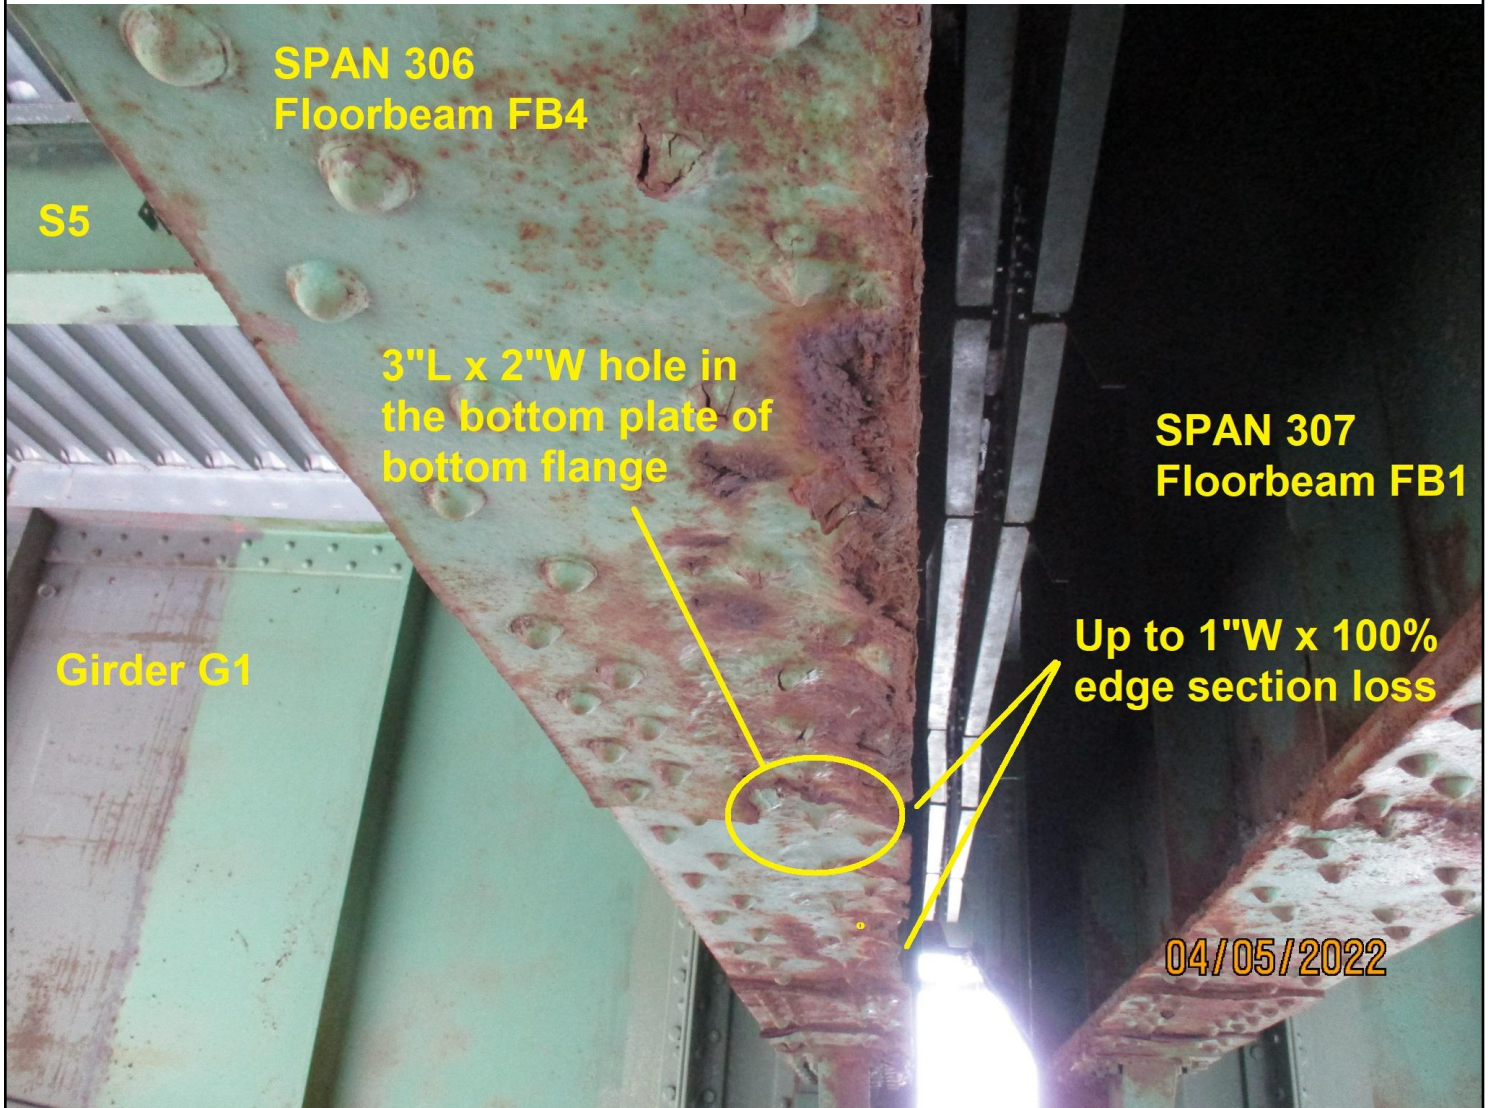
Photo Number: 4

**Attachment Description:** Span 306 at Pier 306, Floorbeam FB4 between Girders G1 and G2. Heavy pitting and 100% edge section loss in bottom flange. Looking Left.

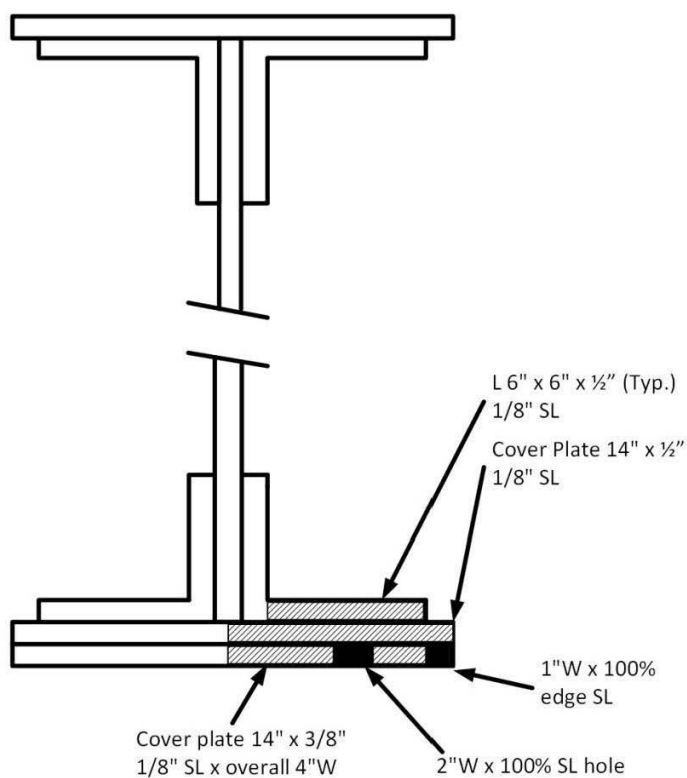
Photo Number: 5

$$\text{Bottom Flange area} = 12" \times 0.5" + 14" \times 0.5" + 14" \times 0.375" = 18.25 \text{ in}^2$$

$$\text{Remaining Bottom Flange Area} = 6" \times 0.5" + 6" \times 0.375" + 7" \times 0.5" + 7" \times 0.375" + 7" \times 0.375" + 2" \times 0" + 1" \times 0" + 4" \times 0.25" = 15.0 \text{ in}^2$$

$$\text{Overall Section Loss} = (1 - 15/18.25) \times 100\% = 17.8\%$$

***Attachment Description: Section A-A Sketch in SN306 at Pier 306 Floorbeam FB4***

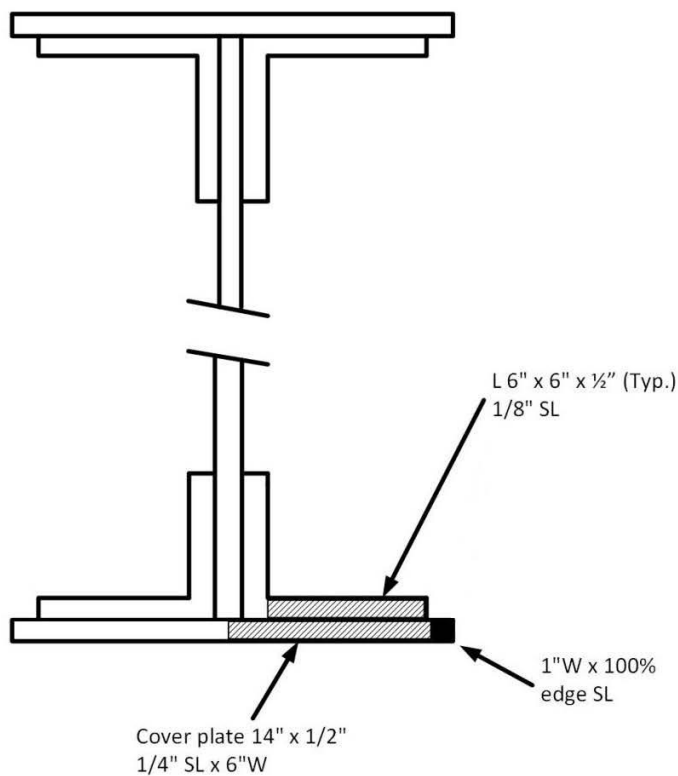
Photo Number: 6

$$\text{Bottom Flange area} = 12" \times 0.5" + 14" \times 0.5" = 13 \text{ in}^2$$

$$\text{Remaining Bottom Flange Area} = 6" \times 0.5" + 6" \times 0.375" + 7" \times 0.5" + 6" \times 0.25" + 1" \times 0" = 10.25 \text{ in}^2$$

$$\text{Overall Section Loss} = (1 - 10.25/13) \times 100\% = 21\%$$

***Attachment Description: Section B-B Sketch in SN306 at Pier 306 Floorbeam FB4***

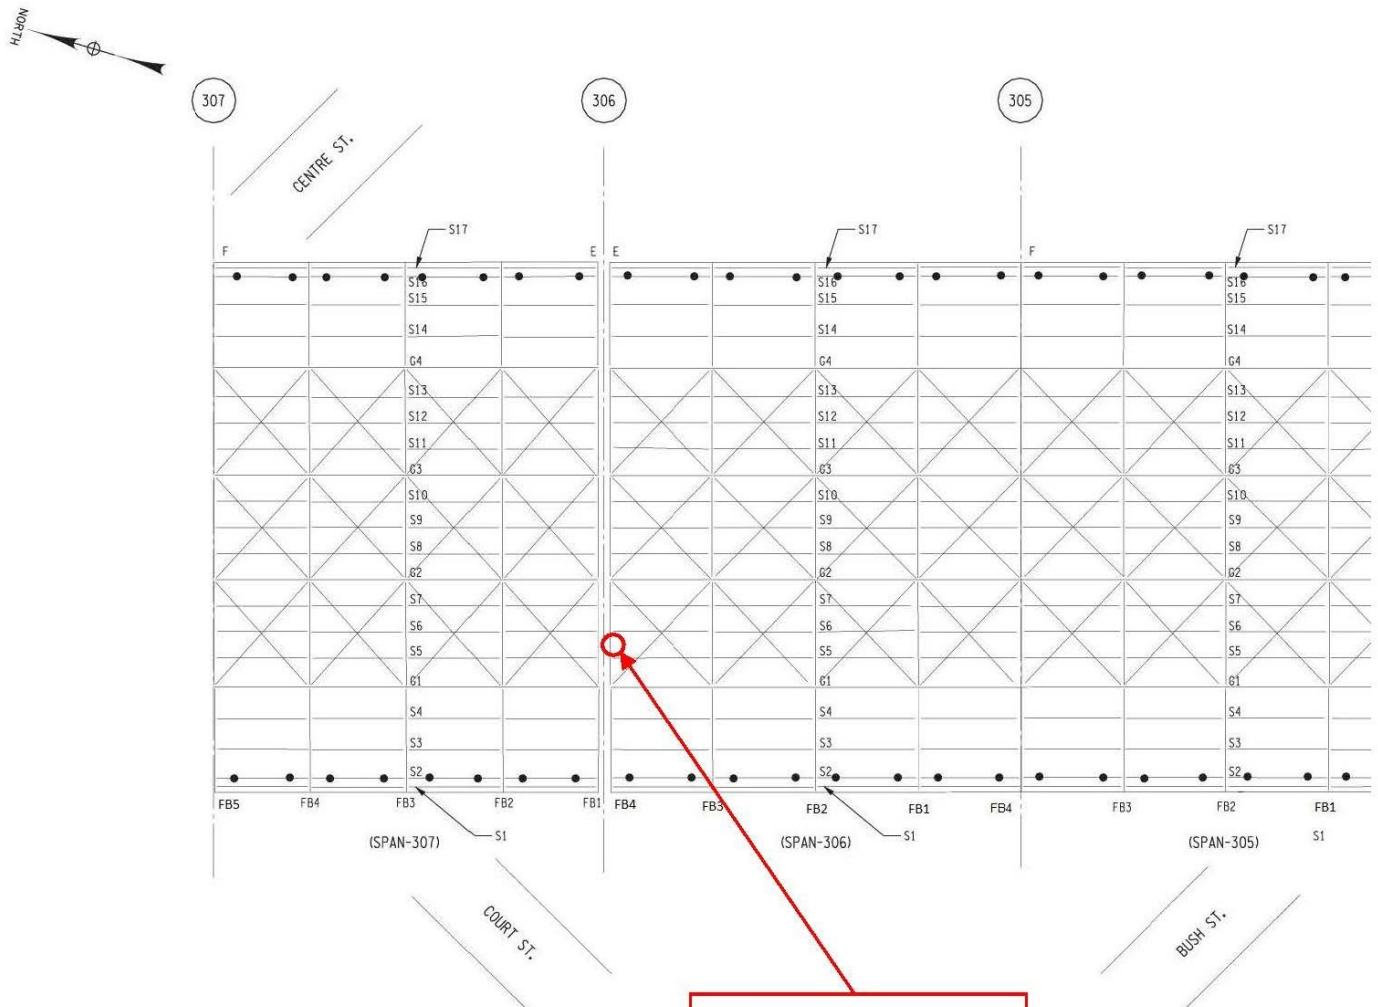
Photo Number: 7

**YELLOW FLAG  
LOCATION  
No. NB2228W020**

**Attachment Description: SN306 FB4 at Pier 306 Framing Plan**
